# SERVICE BULLETIN

BT02-007

## 2002 ALTIMA; BUZZ NOISE AT 2500-2700 RPM, MODERATE LOAD

**APPLIED VEHICLE:** 2002 Altima (L31)

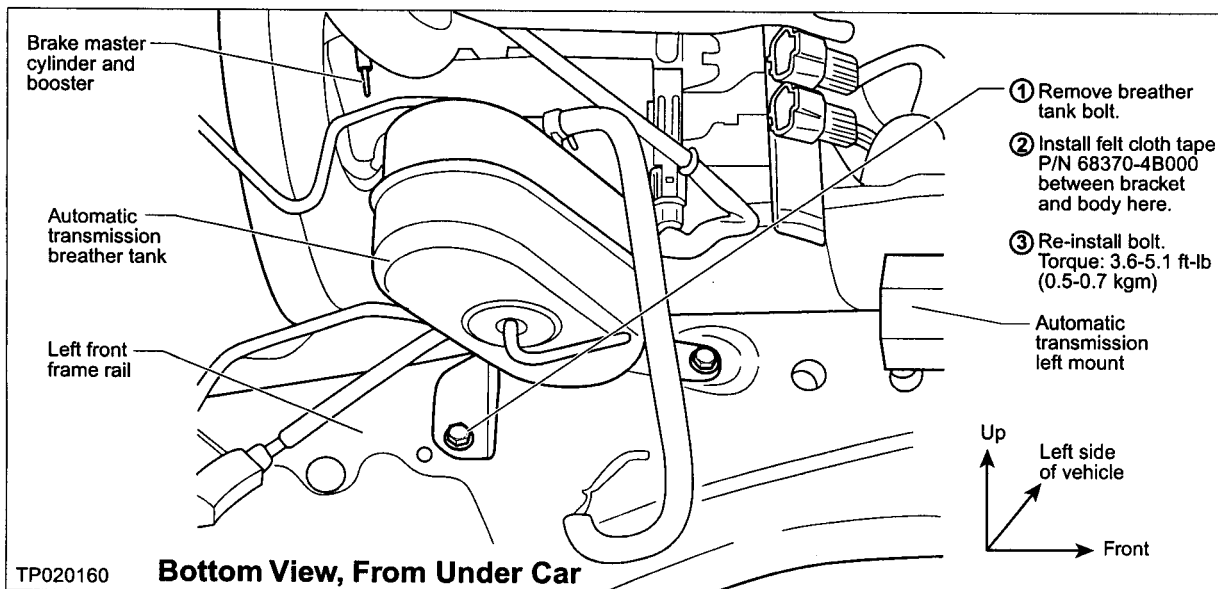
Figure 1

The automatic transmission breather tank bracket may be resonating against the left front frame rail, where it is mounted. Use the Service Procedure below to repair the incident if it should occur.

1. Verify the incident as described in the Service Information, above.
2. Locate the tank and repair the incident as shown in Figure 1.

DESCRIPTION	PART #	QUANTITY
Felt Cloth Tape	68370-4B000*	As needed
